ERDC/CHL TR-04-3

**Demonstration Project on Dredging  
and Marsh Development Using a Flexible-  
Discharge Dustpan Dredge at Head  
of Passes/Southwest Pass Mississippi River**

June 2004

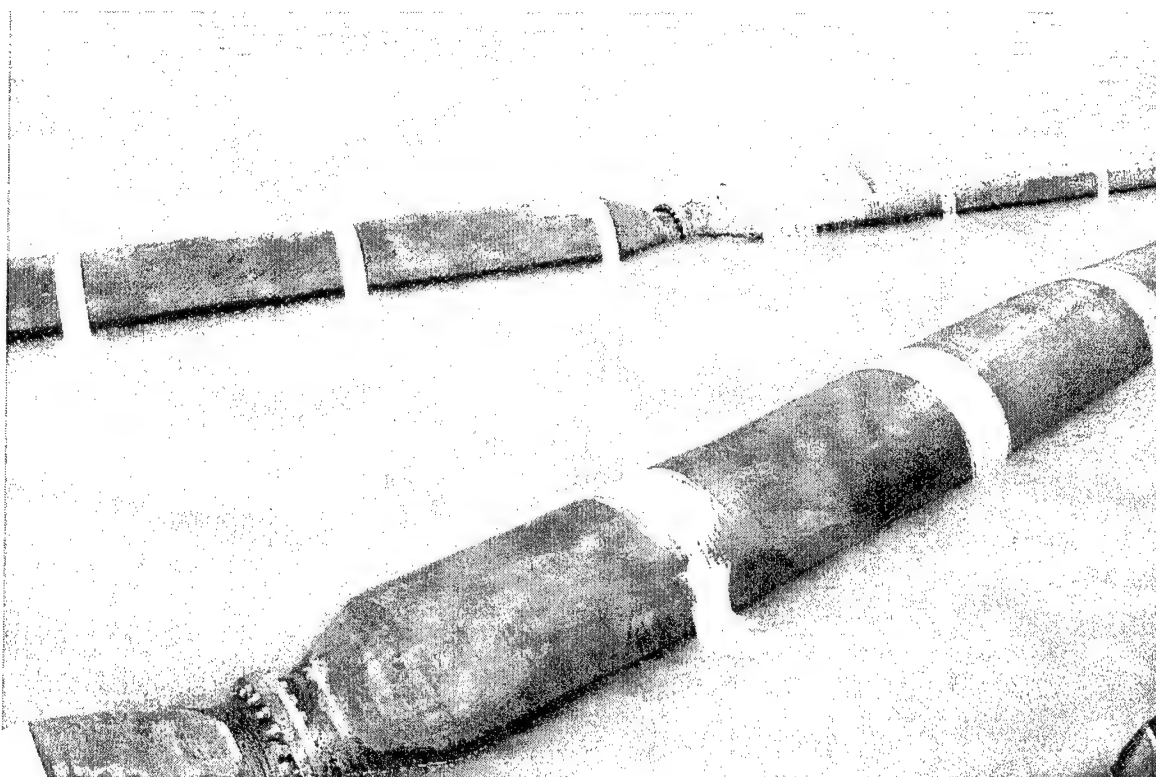
Photo 12. Sections of floating hose

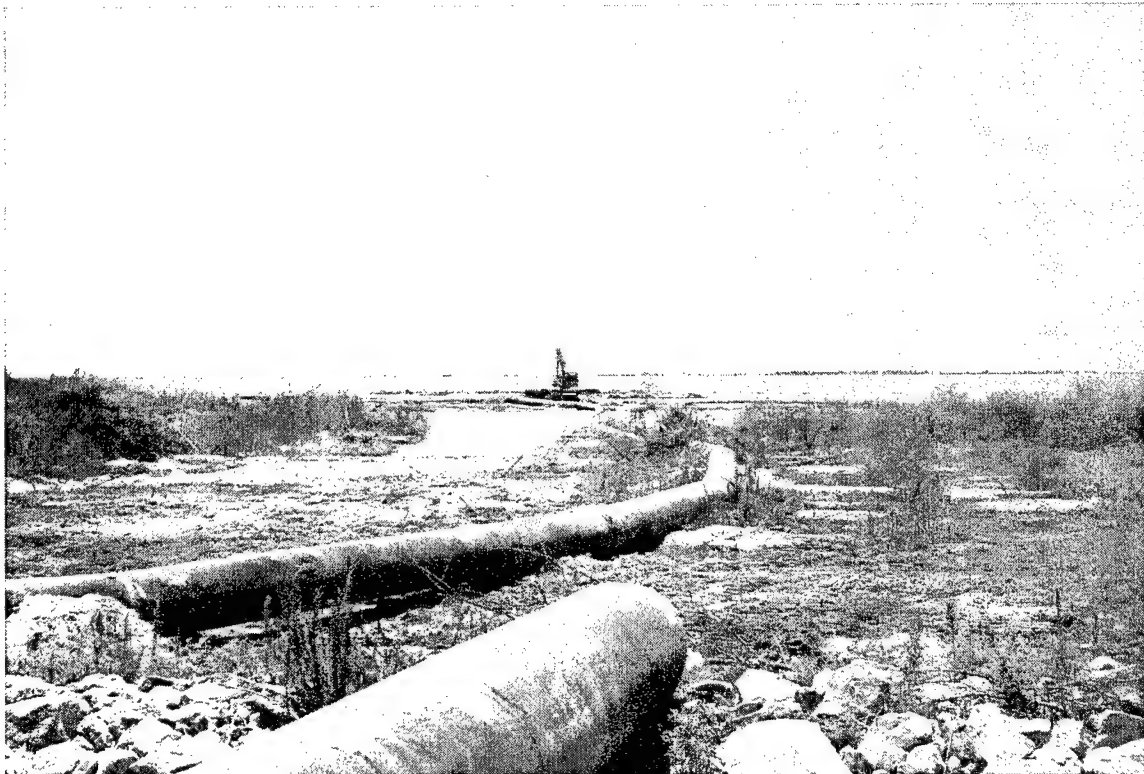
Photo 14. Discharge pipe across dike, pasture land, and existing wetlands

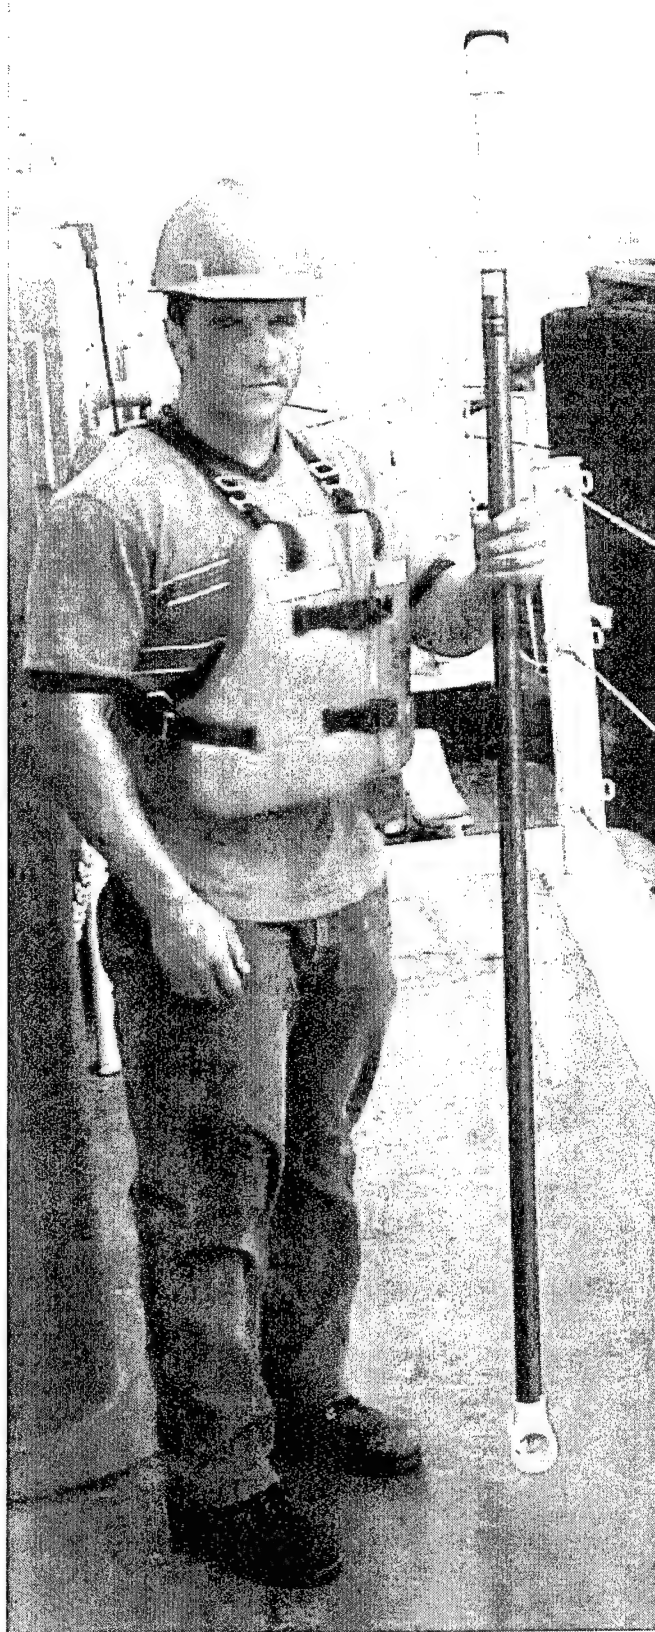
Photo 27. FP201 Global Flow Probe (wand not extended)

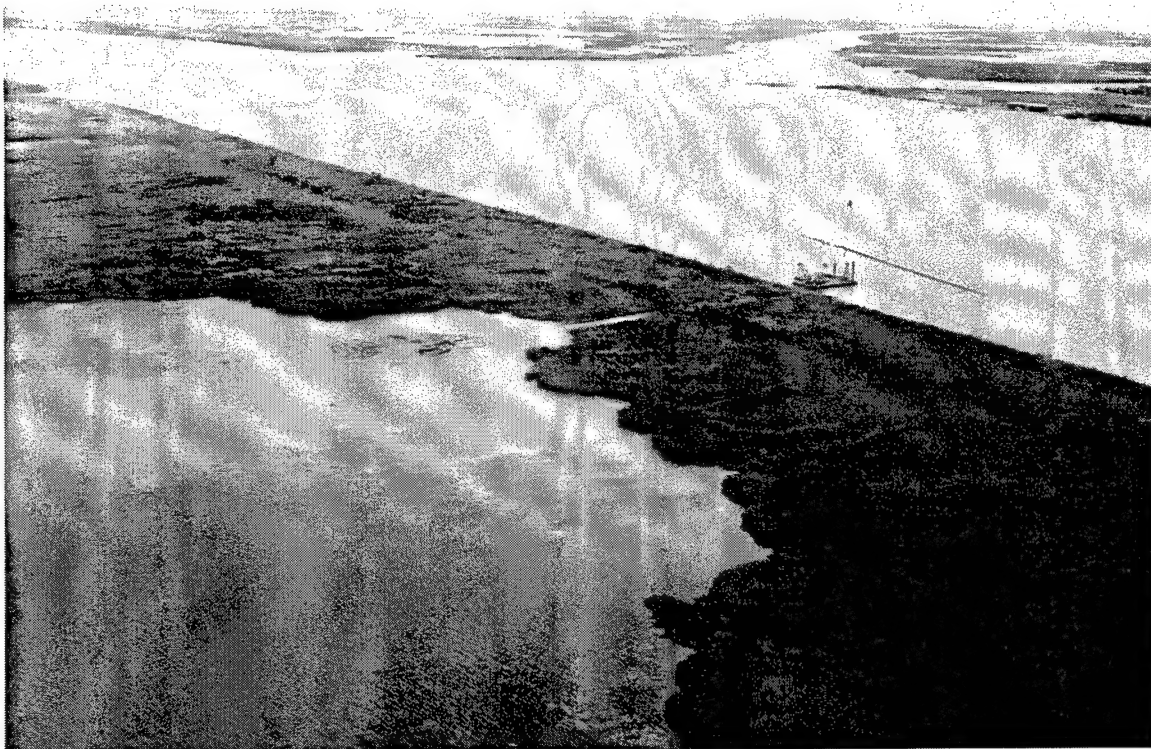
Photo 29. Before dredging aerial photo of placement site

Photographs of the BD and AD placement site are shown in Photos 29 and 30, respectively. BD and AD placement site surveys were conducted by the contractor's survey crew and inspected by MVN, using airboats, mobile DGPS for horizontal positioning, and spirit leveling for vertical control. The results from these surveys are plotted on Figures 11 and 12 (BD and AD surveys, respectively). The difference plot between the BD and AD surveys is shown in Figure 13. The dredged material deposit's footprint covers an area of approximately 20 acres. From the surveys, the contractor calculated a deposition volume of 177,700 cu yd. Assuming a 20 percent loss in fines in runoff, this volume was adjusted up to a gross volume of 222,000 cu yd. Contract specifications required that no dredged material exceed a vertical placement height of +3.5 ft MLG, but Figure 12 (referenced to the MLG datum) indicates elevations that exceed +3.5 ft. This resulted from the impact of an inspection conducted 13 June of the placement area, when USACE and OAS personnel discovered several least tern and American avocet nests containing eggs (Photo 31). The nests had been constructed some distance from the active placement point and were not being disturbed, but MVN decided to terminate the grading operations, along with the dredging operations, at 2100 hr on 13 June to preclude any damage to the nests. This rapid colonization by the least terns and American avocets, as well as other species, is an aspect that should be considered for future dredging projects of a similar nature.

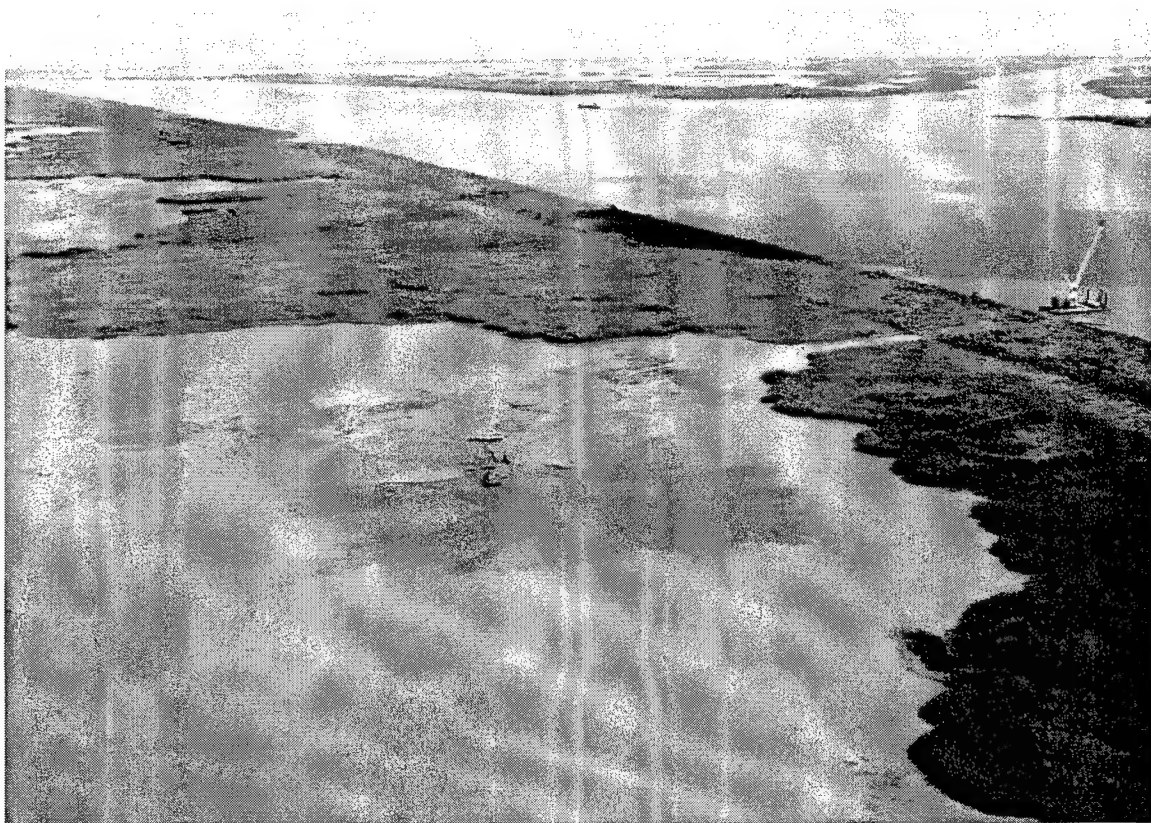
Photo 30. After dredging aerial photo of placement site
